# Manhole Inspection Summary

Manhole # S17K\_\_020MH

Insp Date: **3/6/08 9:37 AM**

**Location** Address: **310 franklin-alley-mchenry**

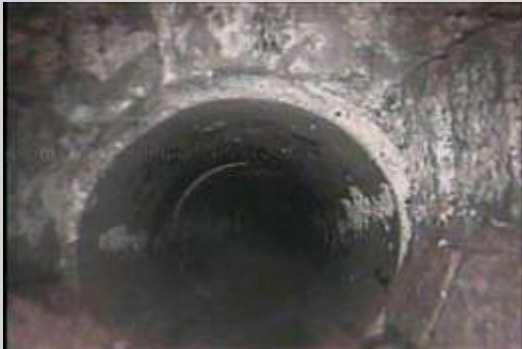
12 O'Clock Outflow

8 in. Circular Gravity Sewer  
Pipe Out @ 12 O'Clock

Pipe Height: **8.4** (in.) Rod and Bar (Angled)  
Pipe Material: **Clay** ☐ Pipe Lined  
Invert Depth: **8.05** (ft.) Flow Characteristics: **Slow**  
Deposits: ☒ None ☐ Mud ☐ Sludge ☐ Debris ☐ Grease  
Silt Depth: **0** (in.) Deposits Extent:  
Infiltration: **None** Pipe Seal Cond: **Sound**

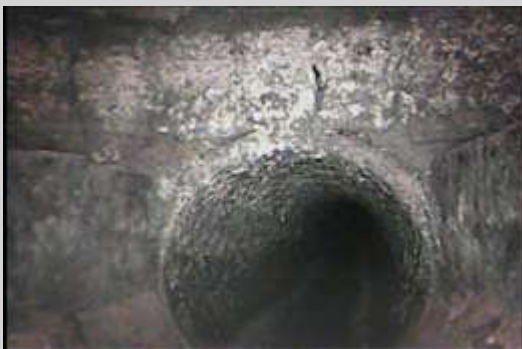
4 O'Clock Inflow

8 in. Circular Gravity Sewer  
Pipe In @ 4 O'Clock

Pipe Height: **8.4** (in.) Rod and Bar (Angled)  
Pipe Material: **Clay** ☐ Pipe Lined  
Invert Depth: **7.88** (ft.) Flow Characteristics: **Slow**  
Deposits: ☒ None ☐ Mud ☐ Sludge ☐ Debris ☐ Grease  
Silt Depth: **0** (in.) Deposits Extent:  
Infiltration: **None** Pipe Seal Cond: **Sound**

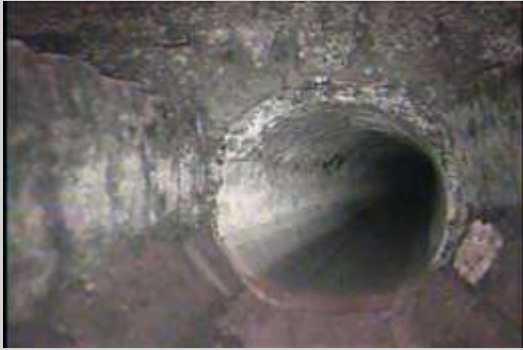
7 O'Clock Inflow

8 in. Circular Gravity Sewer  
Pipe In @ 7 O'Clock

Pipe Height: **8.4** (in.) Rod and Bar (Angled)

Pipe Material: **Clay** ☐ Pipe Lined

Infiltration: **None** Pipe Seal Cond: **Sound**
